LEXINGTON INCIDENT DETECTION SYSTEM EVALUATION REPORT

Research Report
KTC-05-37 / LFUCG-02-1F

November 2005

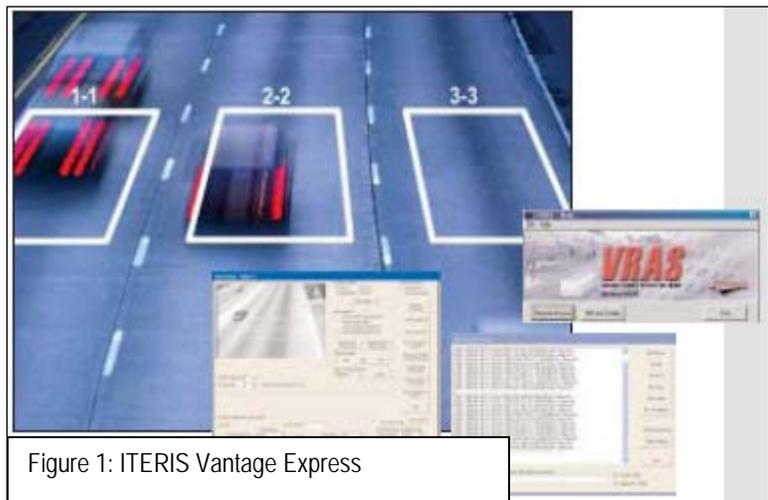
Figure 1: ITERIS Vantage Express

The Vantage Edge system can be installed to provide permanent or temporary vehicle detection applications without embedded loops in all types of weather, 24-hours a day. The integrated software of the Vantage Edge system is used to draw detection zones on the video camera image defining detection zones, and zone properties. The processor module analyzes the camera image to determine when a vehicle is present in a zone. Vehicular detection information is passed to the traffic control equipment. Vehicle detection may be in either “presence” or “pulse” mode; Presence mode was used in all applications for this study. The Vantage Edge system is typically deployed to provide detector applications for intersection operations. (1)

Additional software, Vantage Express, is available for data collection applications for count, classification and speed studies. Vantage Express was not deployed in the evaluation due to the necessity of an independent communication link.

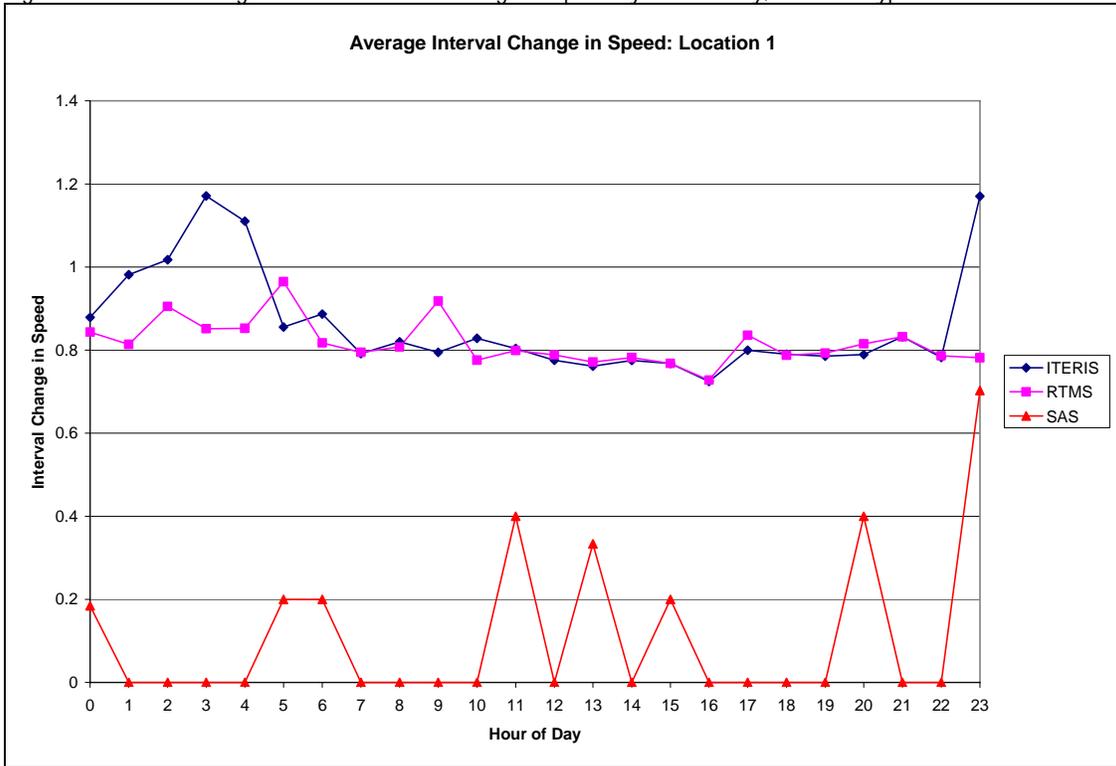
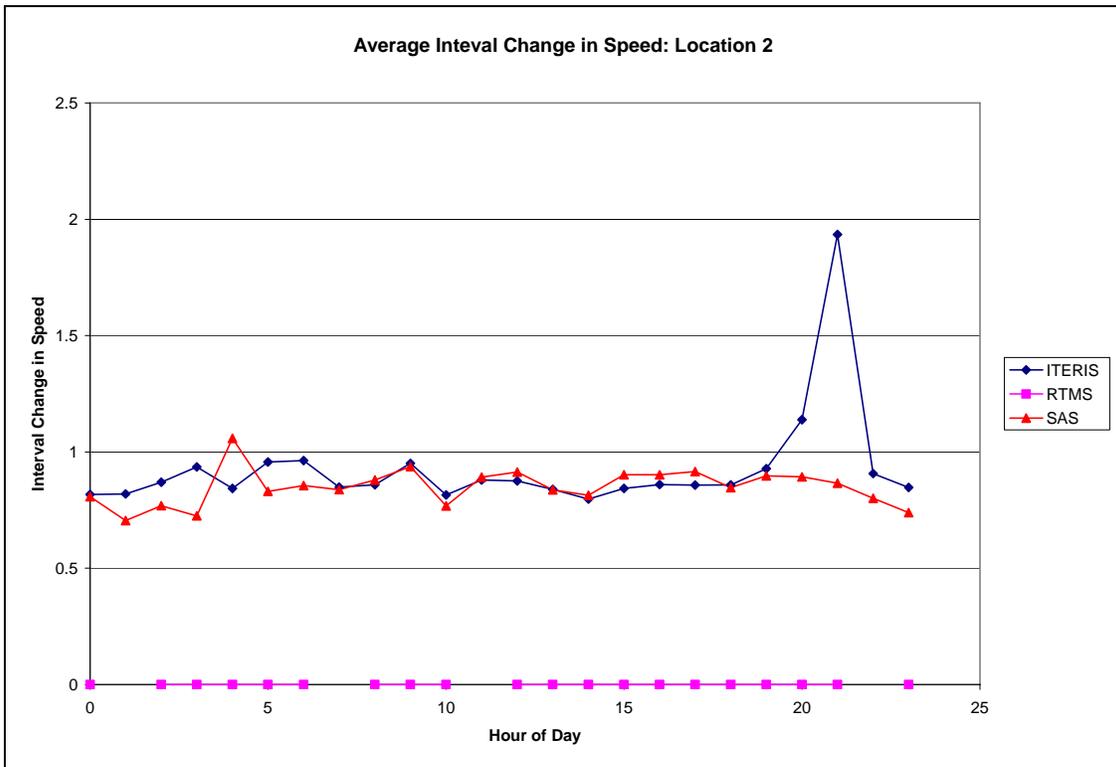
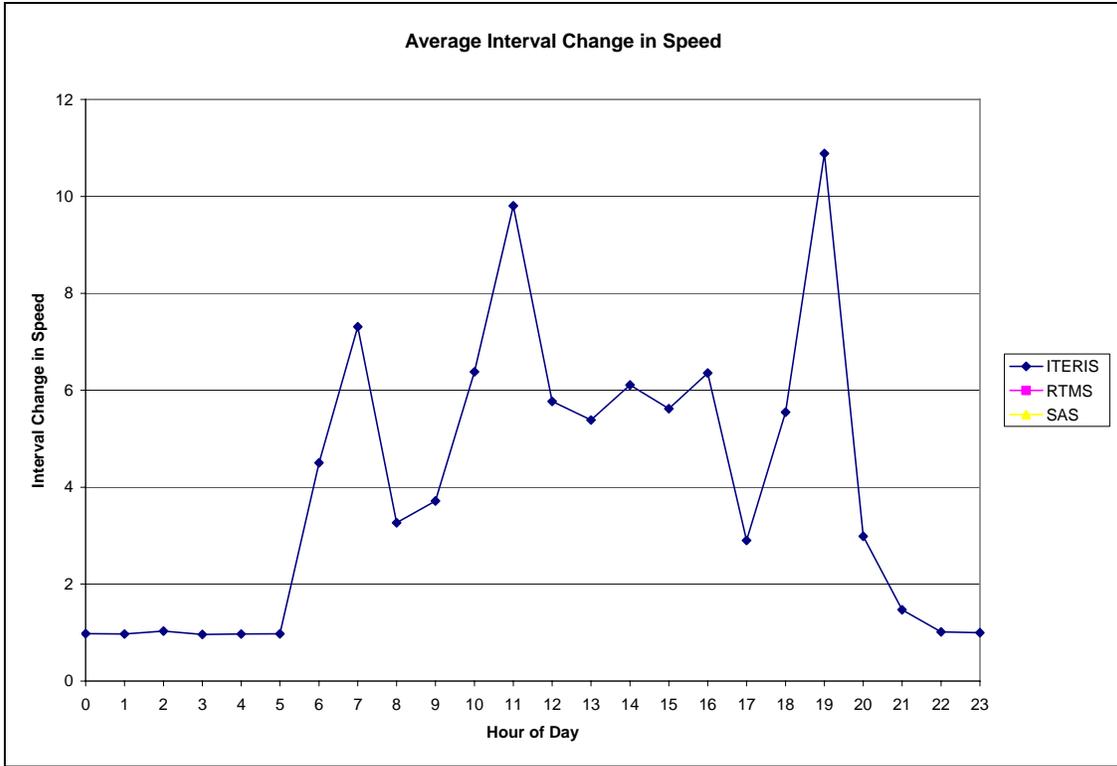
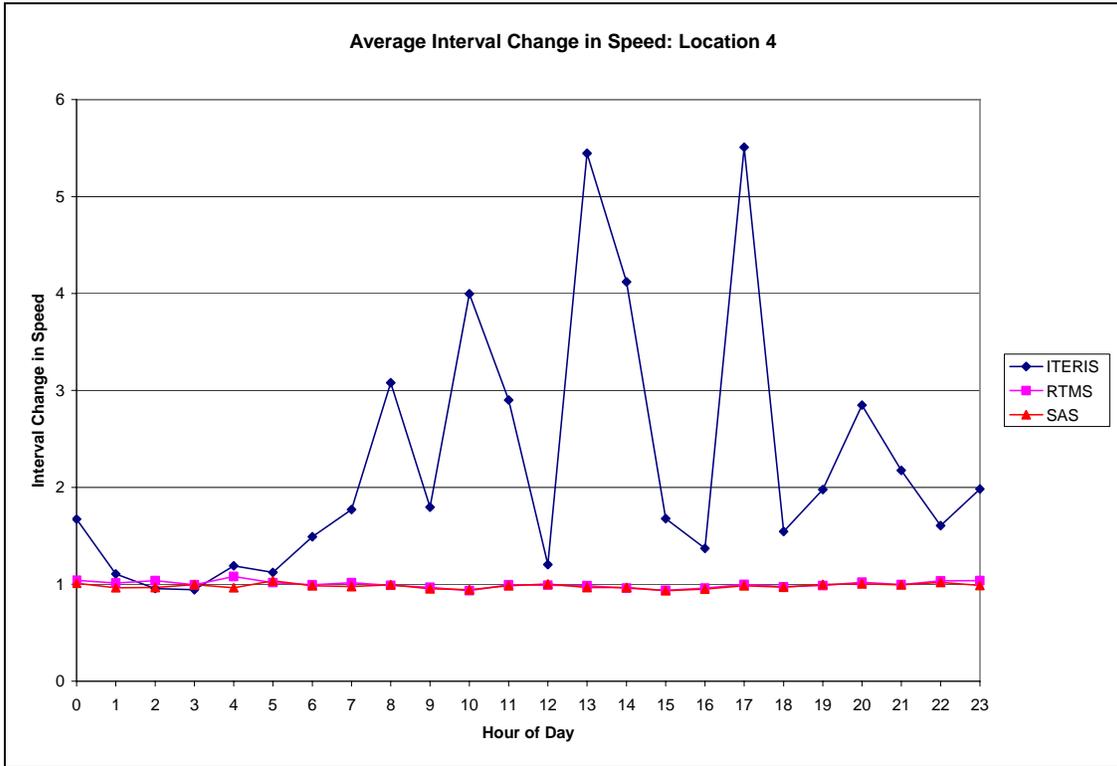
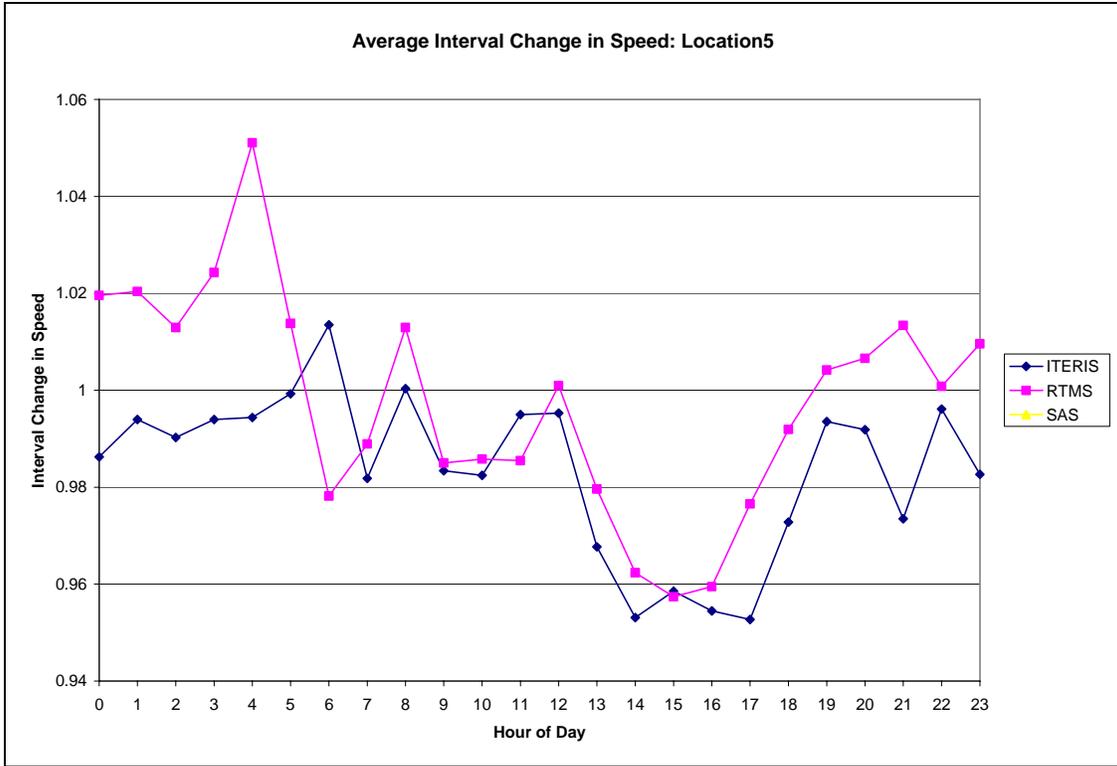
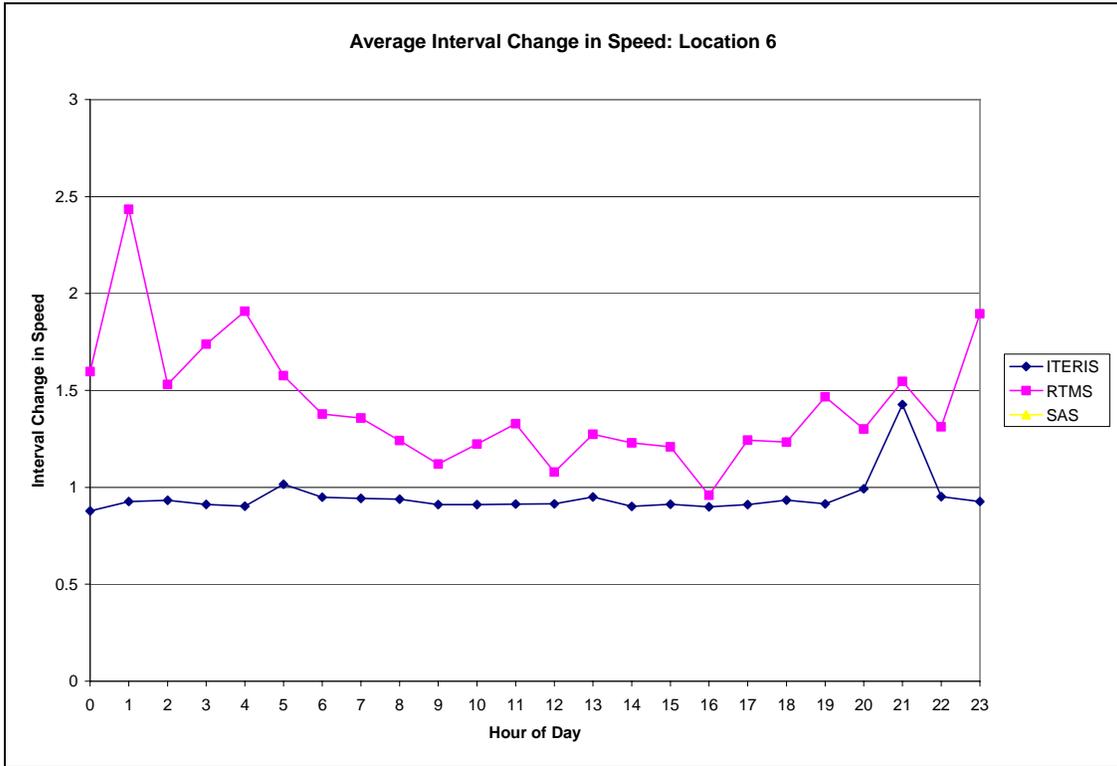
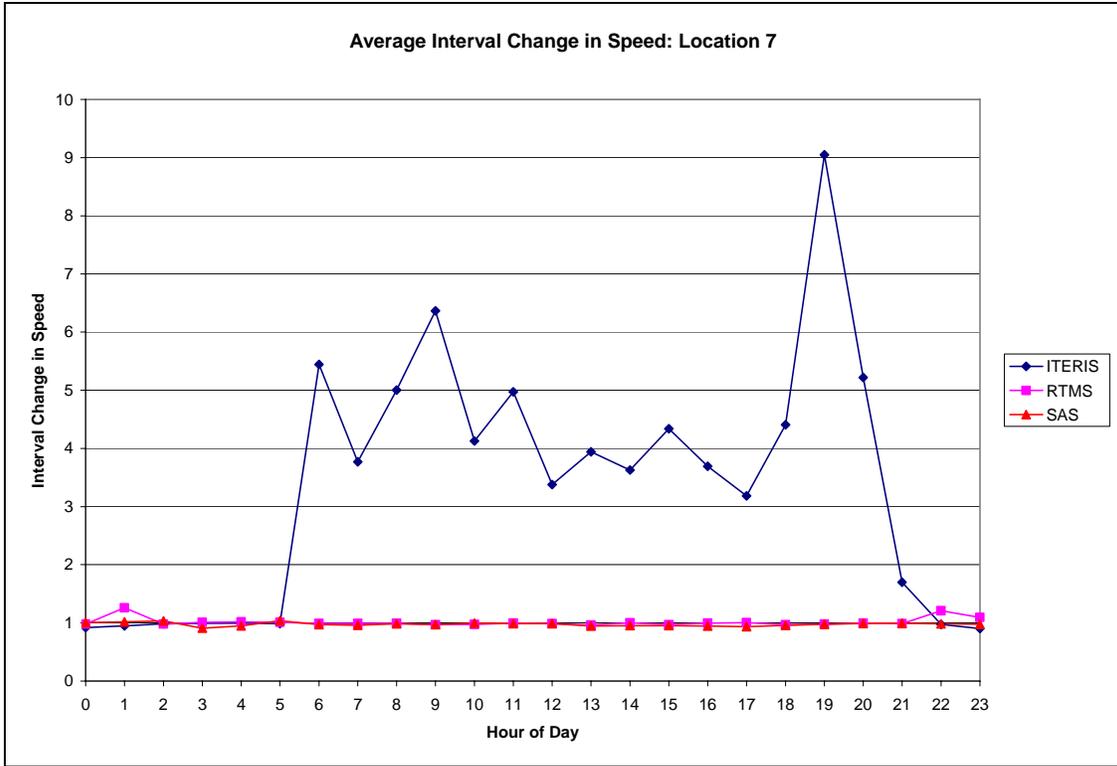
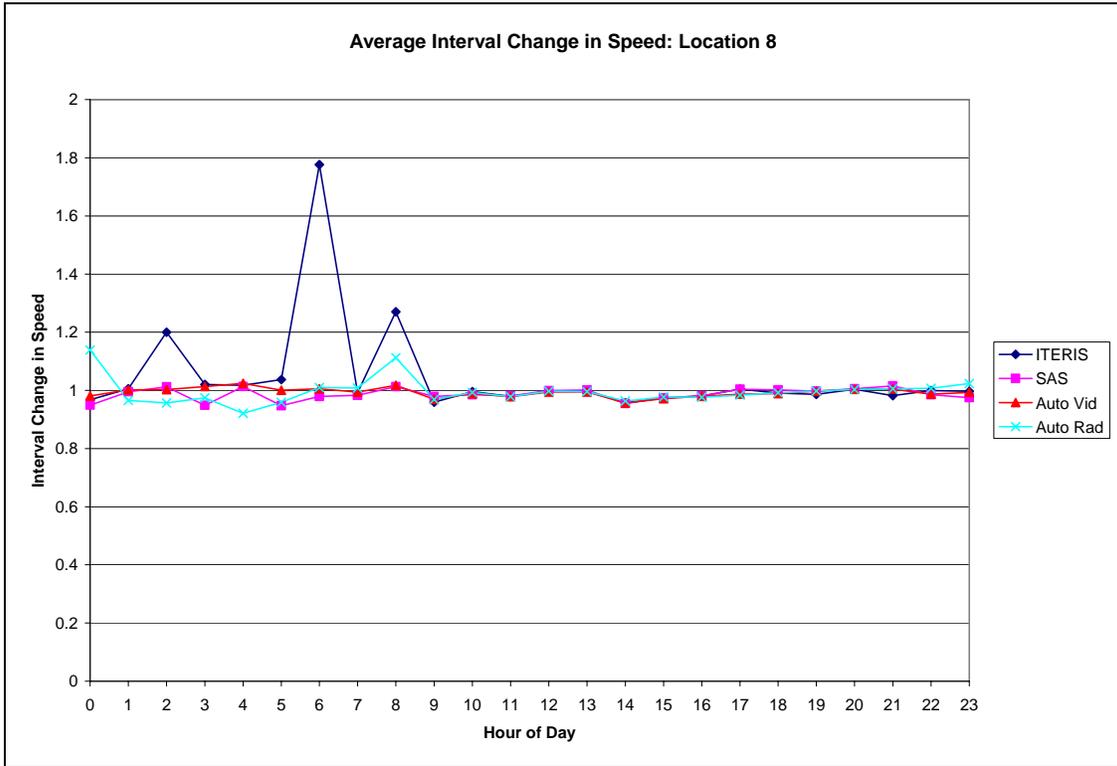
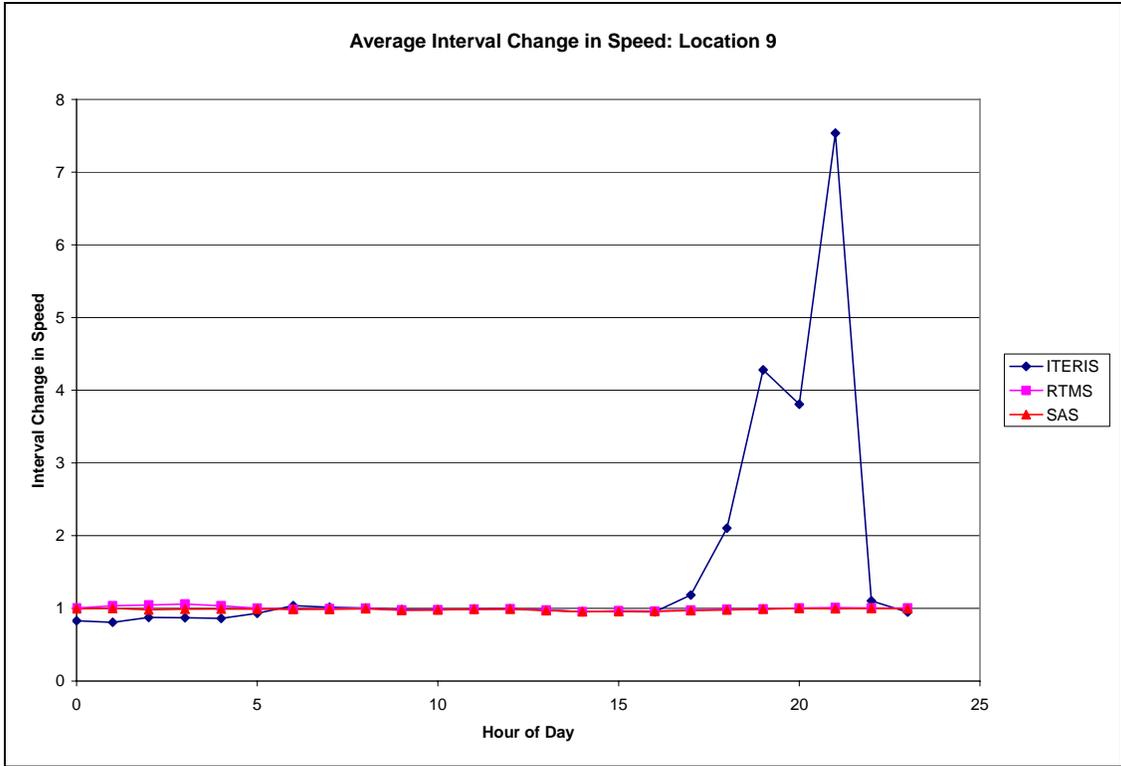
Figures A19-A27: Average Recorded Interval Change in Speed by Hour of Day, Detector Type and Location

Based upon this analysis no similarities were found between any of the detector pairs examined, except for consistent similarities among the interval change in speed between all detectors at the Richmond Road/Shriners Lane location. The mean interval change in speed for all detectors at this location was between 1 and 1.06. In addition, the following detector pairs at this location showed common interval change in speed observations within a 95 percent confidence interval.
